# The Present Condition of the Building at Syowa Station

Zenkichi HIRAYAMA\*

### 1. Preface

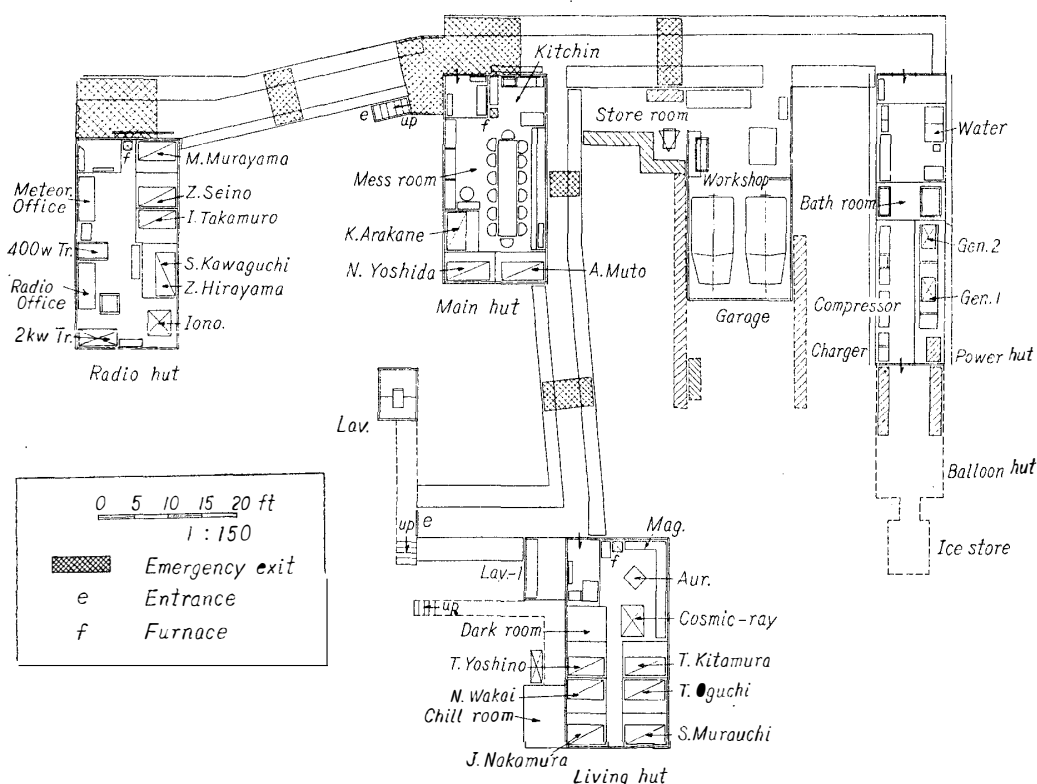
Fig. 2. Plan of living area, 1959.

In this year the building did not get much larger, but its inside was much improved. The setting of emergency exits which also served as lighting windows, and improvement of the doorways were examples of it (see Fig. 2).

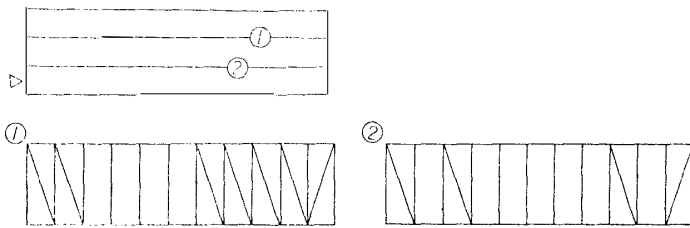
Fig. 5. Tension of a bracing in the roof beam (central part of the roof m/m).

Beams were bent by the tention of the bracing.

As mentioned above, various structural strains were seen quite fairly. No causes

of them are, however, found out, as the original conditions of those parts of the building when it was built are not known to us.

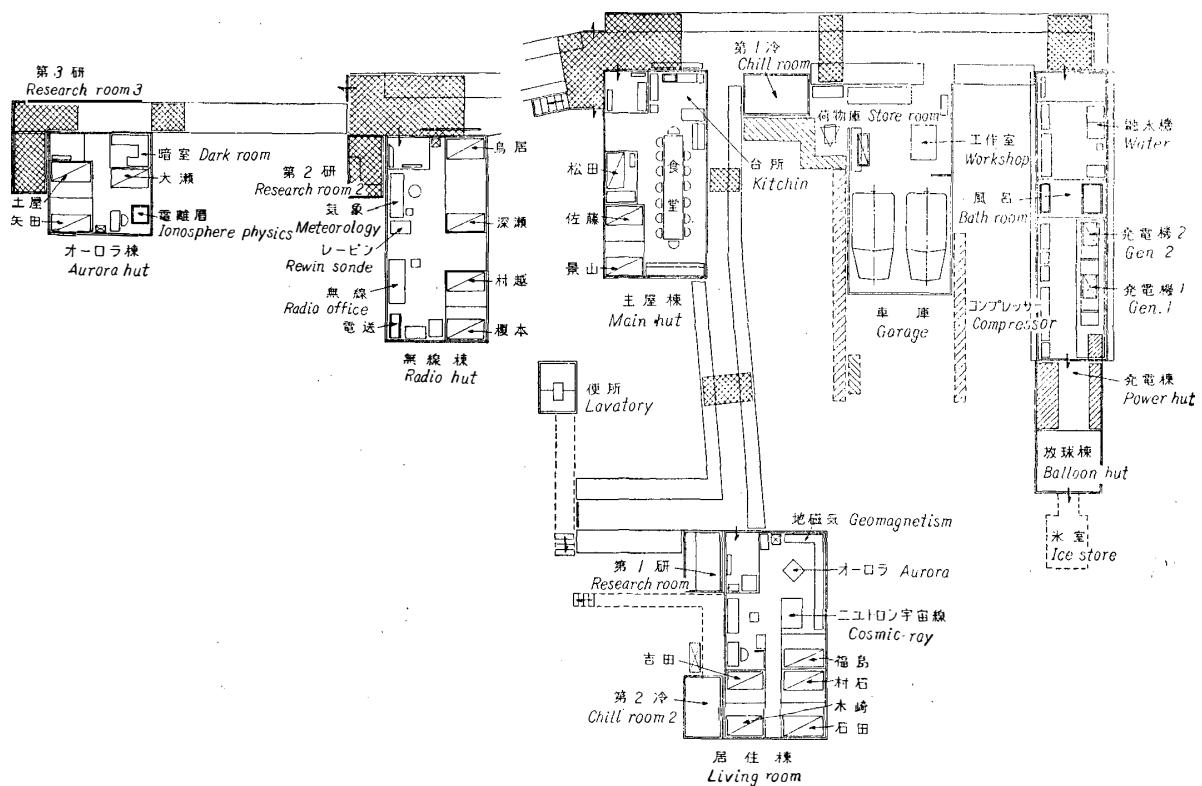
Fig. 6. Plan of living area, 1960.

Every time when the Station was taken over by a new party, the inside of the building should have greatly been remodeled. It might partly be because of differences of the members, but mostly, it was because the present building at the Station have no room to spare and at the increase of members and the change of items for observation it was not ready for use without remodeling. While, as the cabinets, the partition boards, etc. in the building had been standardized, the remodelings were done very easily. A remodeling once a year might be even effective for the fresh spirits of the members.

Here you can see the description in 1960 (Fig. 6).
