## Construction of Ice Domes at Asuka Station in Antarctica

**Abstract:** An attempt was made to construct an ice dome in order to study the construction technique and to examine its deformation by creep and sublimation of ice in the Antarctic. A 10-m diameter membrane was inflated by a ventilator. Stored water was sprayed on it, and sometimes milled snow was blown by a small snow miller. About 13 t of water was consumed for making an ice dome 7 cm thick, 3 m high.

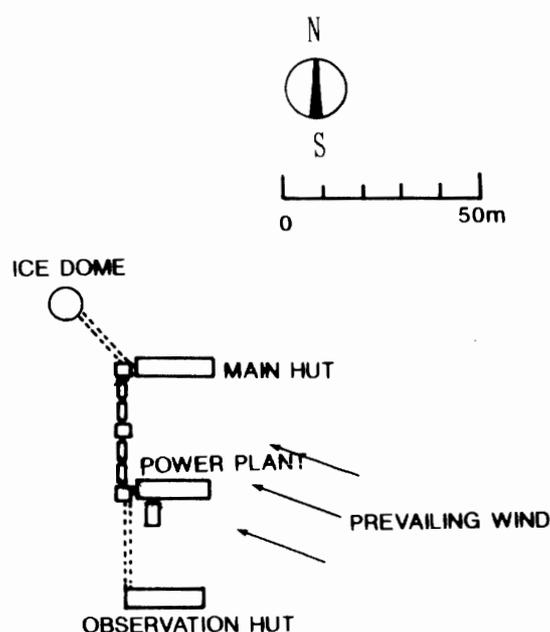
Fig. 2. Buildings of Asuka Station and position of ice dome.

Construction of an ice dome was attempted at a site about 15 m from the main buildings of the station, leeward of the buildings (Fig. 2). At first the construction site was leveled and smoothed by a crawler shovel, and wooden anchors for supporting guy ropes were buried 50 cm deep in the snow.

A snow tunnel was excavated between the main hut and the ice dome in order to use the dome as a doorway of the station (Fig. 2). The opening (1.8 m height, 1.5 m width) was excavated in the wall on September 18, 8 days after removal of the membrane. The length between the ceiling and the floor was measured at twelve points by wire-rolled type transducers as shown in Fig. 4. The data obtained are shown in Fig. 8. The heights of the ceiling at all points except No. 0 and No. 1 decreased with time. Furthermore, the speed of shrinkage increased according to the air temperature shown in Fig. 9. Figure 10 shows accumulative shrinkages over the measurement period. The shrinkage of the center (No. 5) reached 55 mm for 99 days. The average was calculated as 0.55 mm per day. The shrinkage would reach 20 cm in a year if that average value were used. This value suggests that it will be possible to use an ice dome used as a wide covered space in one or two years in the Antarctic.

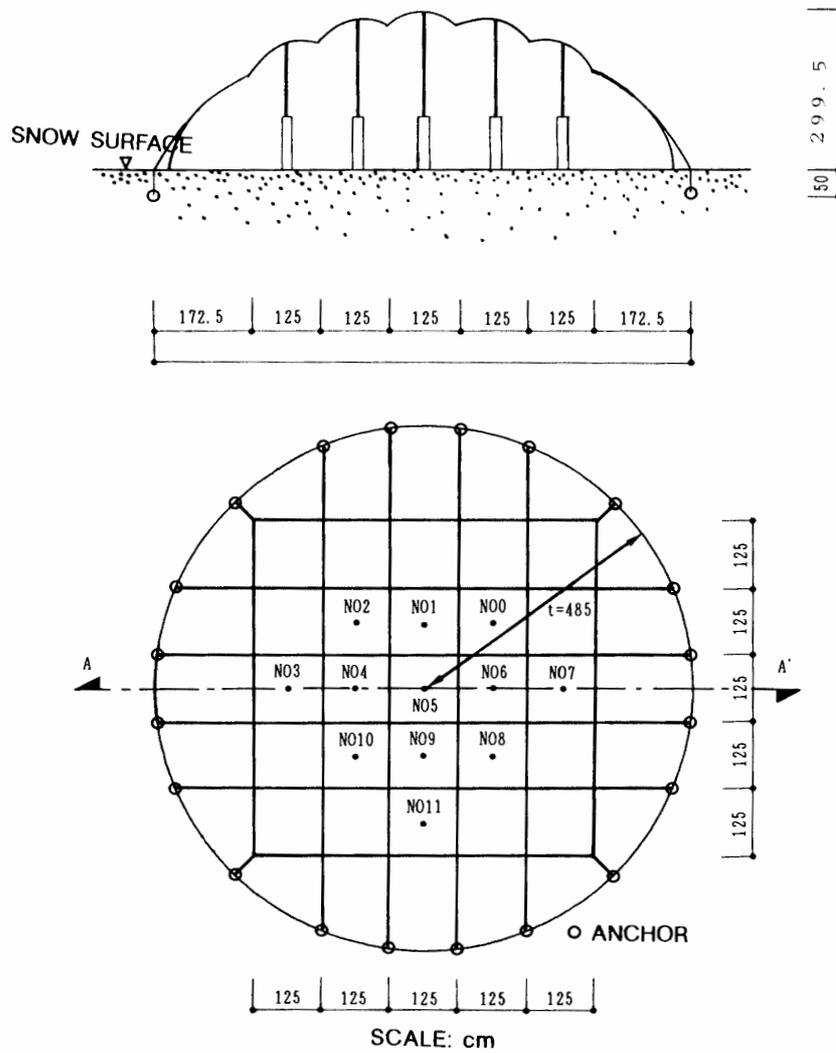
Fig. 4. Plane view and vertical section of the ice dome. Twenty anchors were buried in the snow. Dots on the ice dome (NO.0 to NO.11) indicate positions of transducers for displacement between the snow floor and the ceiling.

A 10-m diameter membrane bag made of polyester fibers with polyvinyl chloride coating was set on the snow surface. The thickness and weight of the membrane were 0.65 mm and 125 kg respectively. Polyethylene guy ropes 9 mm in diameter were

covered on the membrane and the ends were connected to the anchor ropes buried in the snow with carabiners (Fig. 3). A top view and schematic section of the membrane and ropes are shown in Fig. 4. The membrane was inflated by a portable ventilator (maximum air flow 55 m<sup>3</sup>/min) in 30 min (Fig. 5). The mean air temperature of the day (September 4, 1991) was  $-29.9^{\circ}\text{C}$ . After inflating the membrane, the inner air pressure was held at about 343 Pa (35 mm water head) by a vortex blower. The pressure was measured by reading a scale on a U-type pipe gage attached to the membrane.

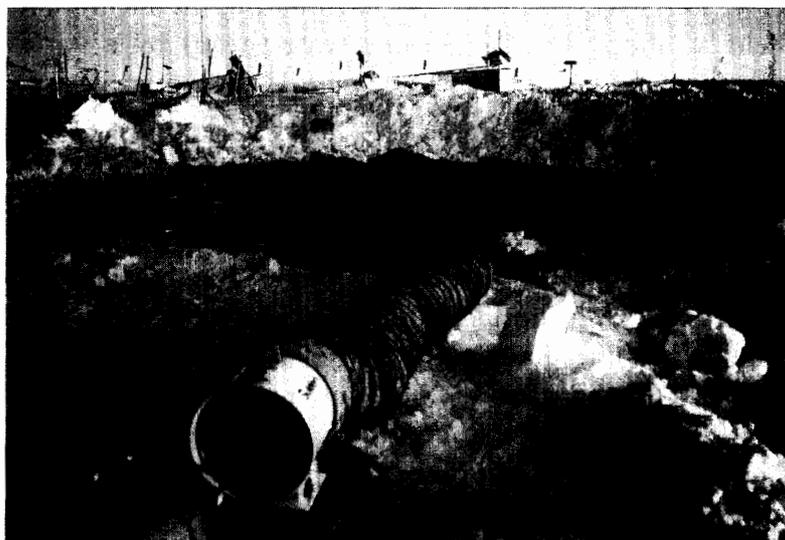
Fig. 5. Spread membrane bag with ventilator.

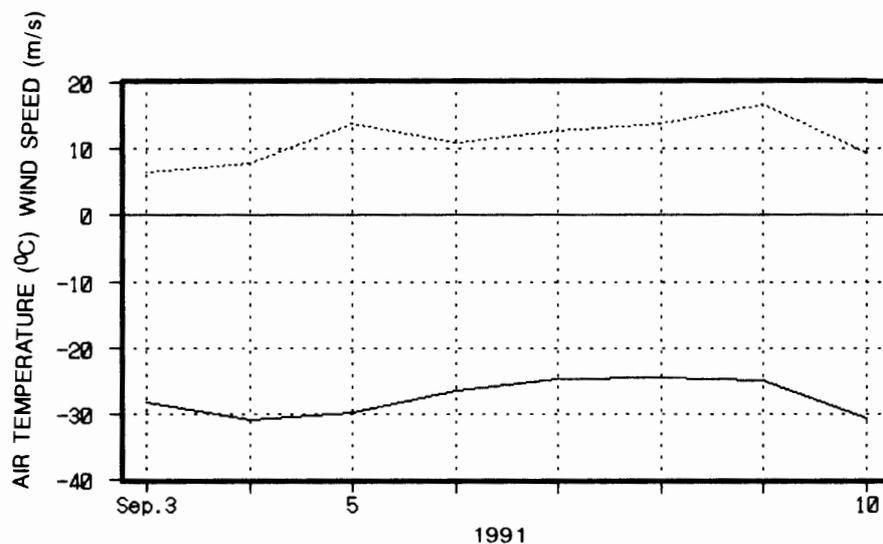
Fig. 6. Climatic condition for the ice dome construction period.

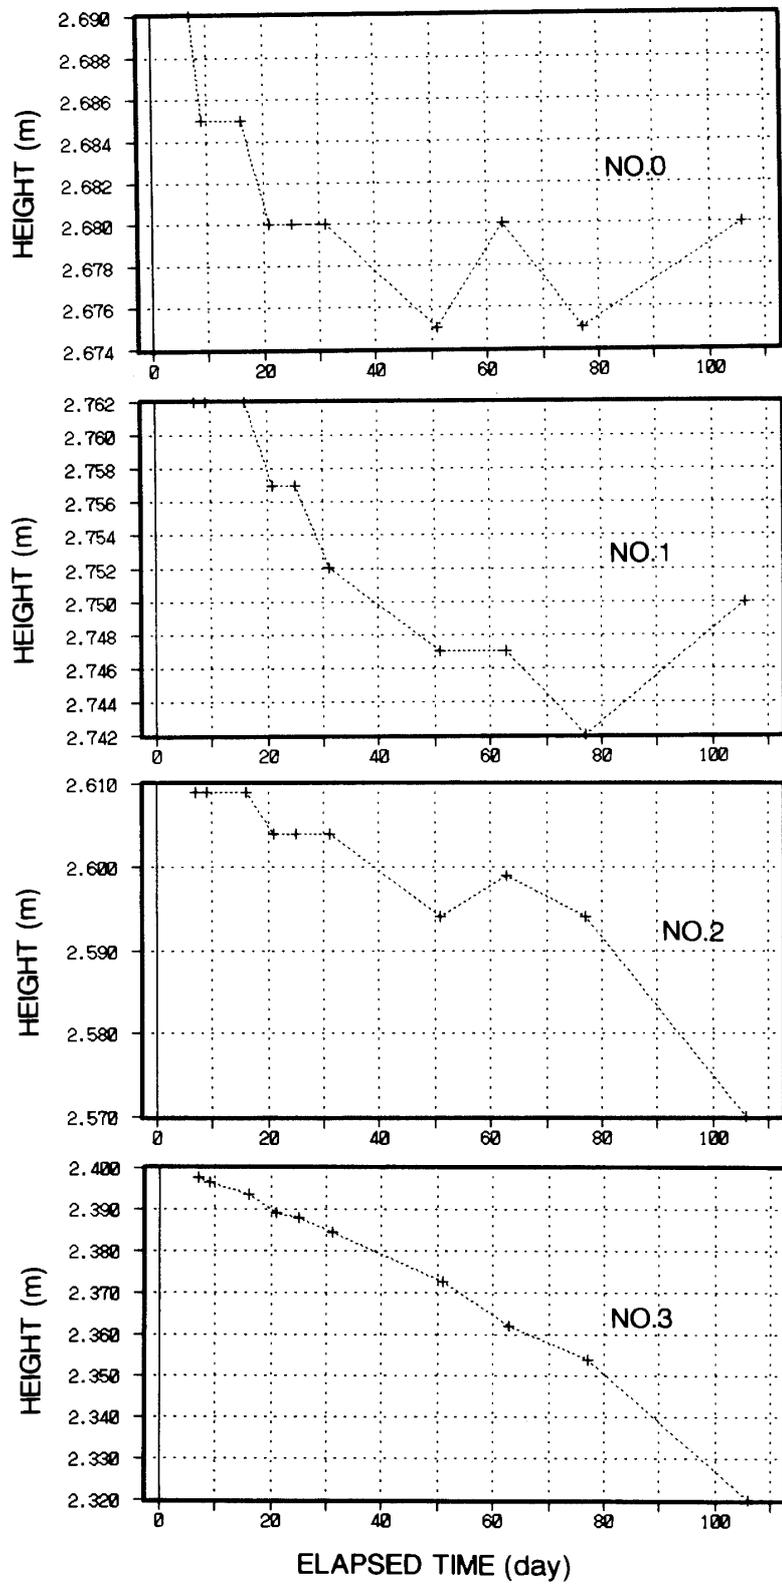
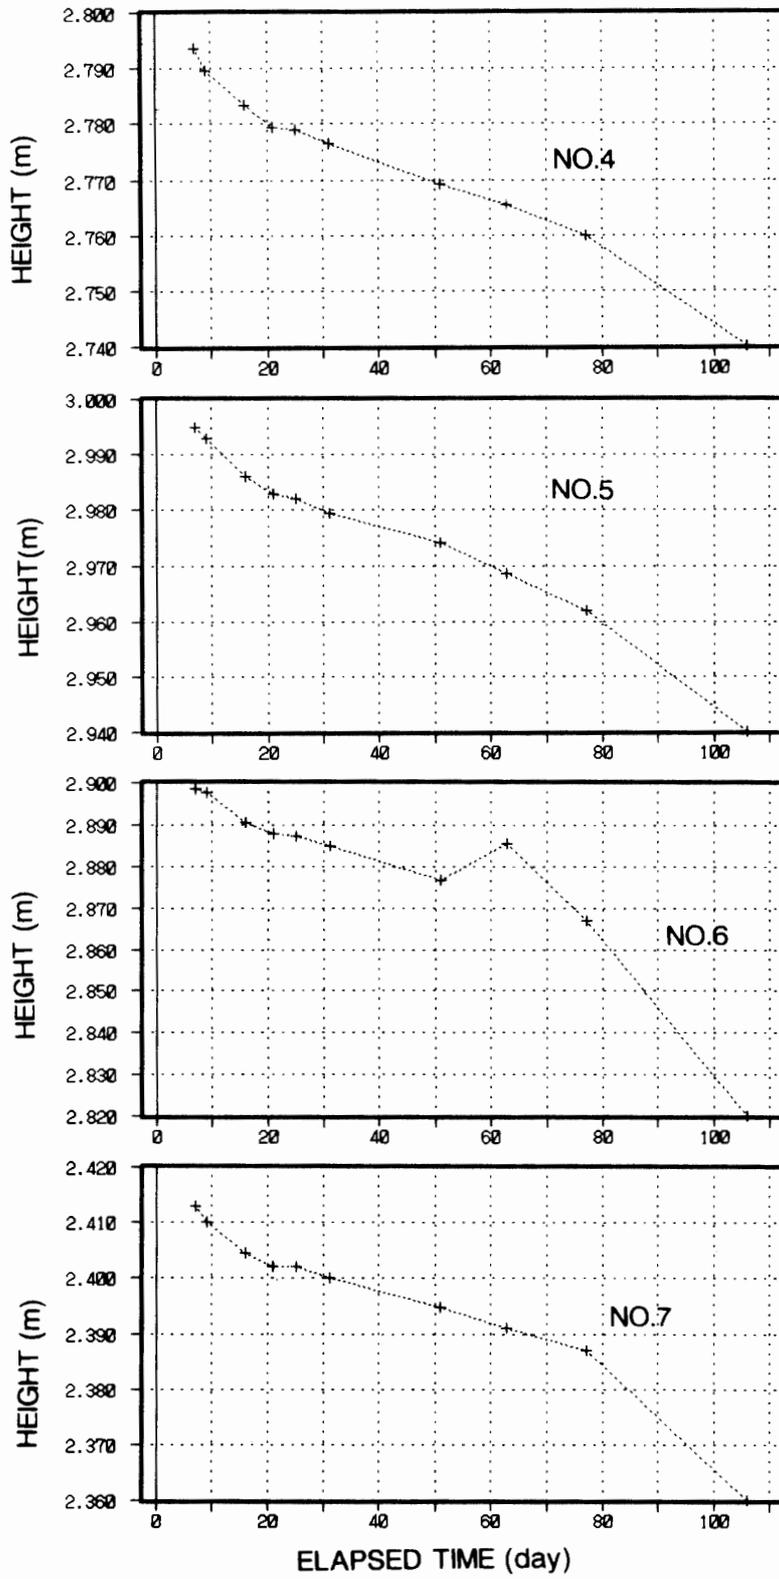
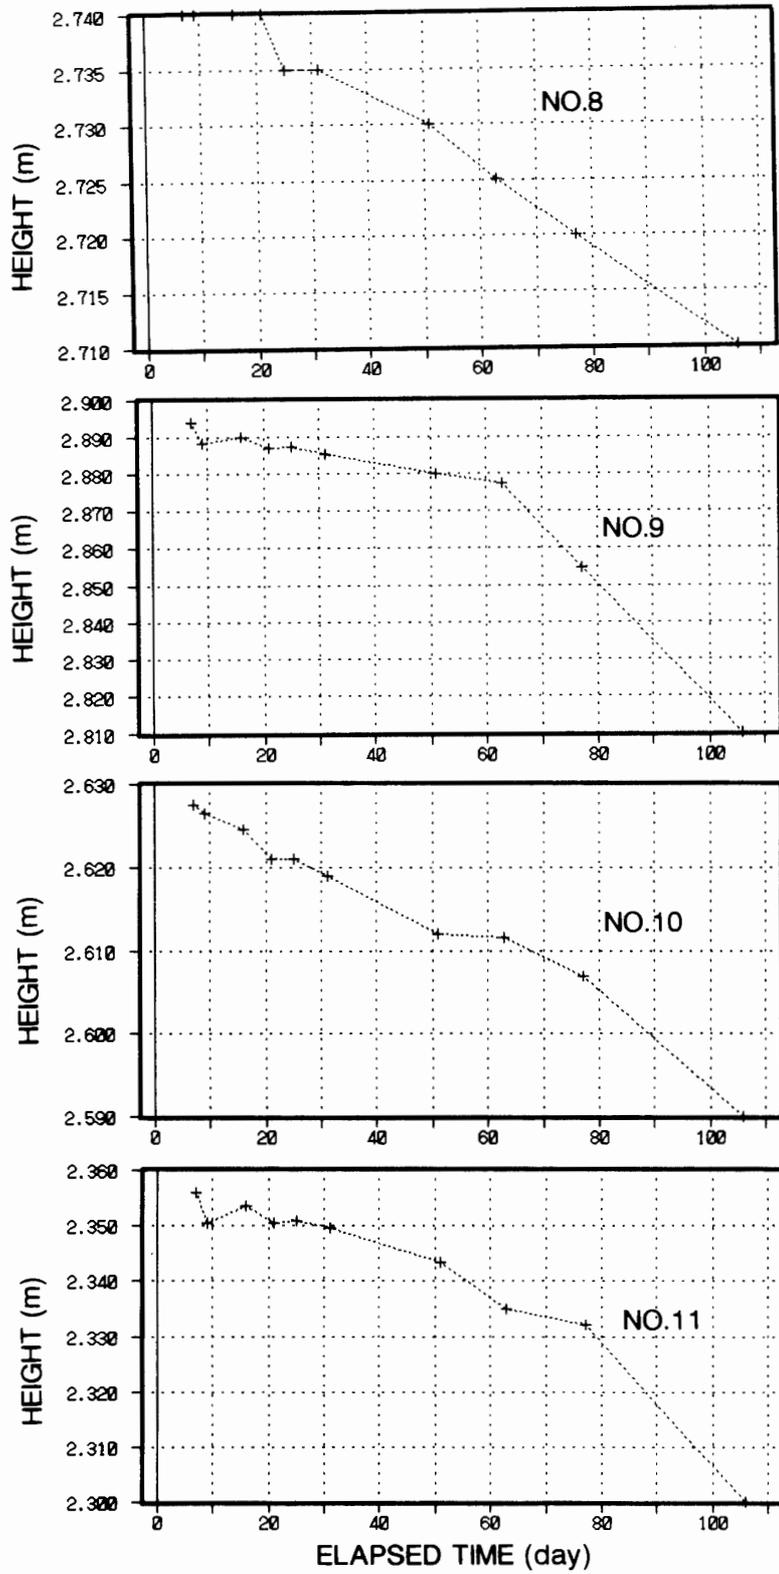
Fig. 8. Height changes at twelve points of the ceiling. The numbers coincide with those in Fig. 4.

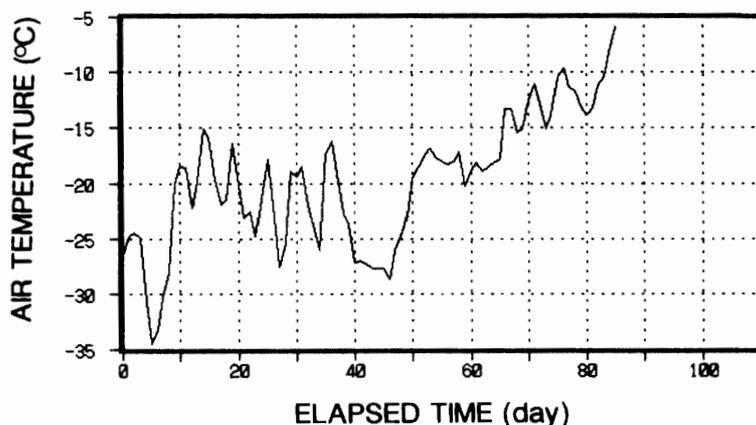
Fig. 9. Change of air temperature for the period of the displacement measurement.

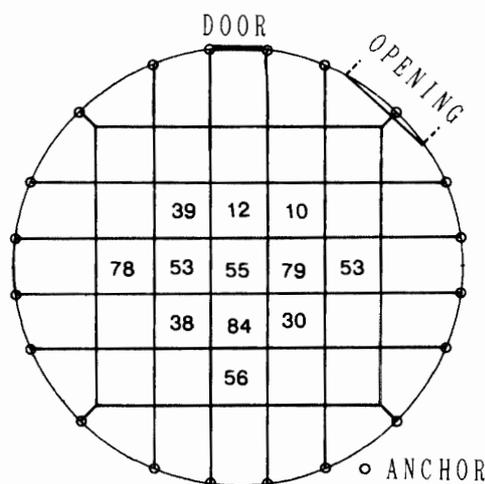
Fig. 10. Accumulated displacement of the ceiling in the ice dome.
