# The Present Condition of the Building at Syowa Station

Zenkichi HIRAYAMA\*

### 1. Preface

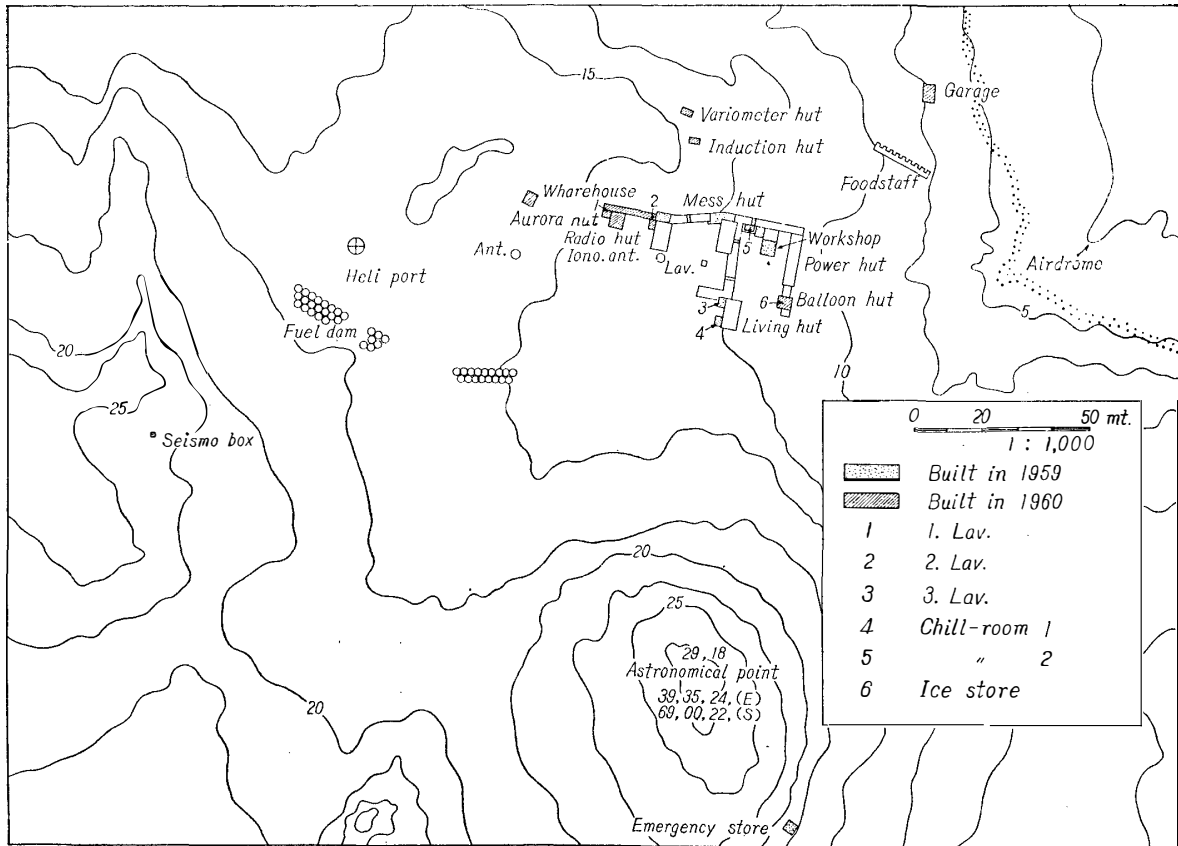
The building at Syowa Station has been remodeled and added by new huts by and by since it was built for the lives of the members of the wintering party at the leave of the first expedition in 1957; and now, in 1960, its space is 413.0 m<sup>2</sup> that is more spacious by 64% than that at first, 250.6 m<sup>2</sup> (see Fig. 1).

Fig. 1. Syowa Station (20, Feb. 1960)
